Cold War Armor After Chechnya:

AN ASSESSMENT
OF THE RUSSIAN T-80

by Major James M. Warford

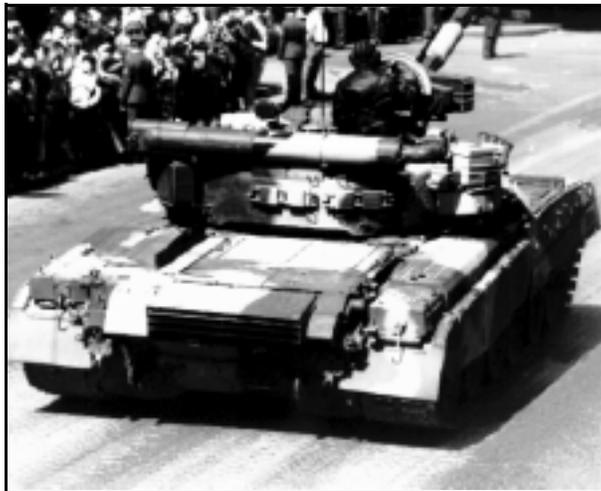
Diesel-powered T-80U parades in Red Square.

sisted that the tank's operating range be improved to allow for eight hours of operation between refuelings. To accomplish this, General Grachev announced that the Russian Armed Forces would move away from using gas turbine engines. "I say clearly to everyone, directors and constructors, [that] we are going to switch over to only using diesel. We are not going to work with gas turbine engines anymore."⁴ This announcement is very interesting for a couple of different reasons. First, the Russians have been working with gas turbine engines since at least the mid-1960s. In fact, the T-80 Base Model PT was the first tank in the world to be fielded with a gas turbine engine when it was put into service in 1976. The GTD-1250 1250-hp gas turbine engine that powers the T-80U is by all Russian accounts a very efficient and successful engine. Although a newer model than that fitted to the T-80BV that fought in Chechnya, the GTD-1250 has been a very strong performer.

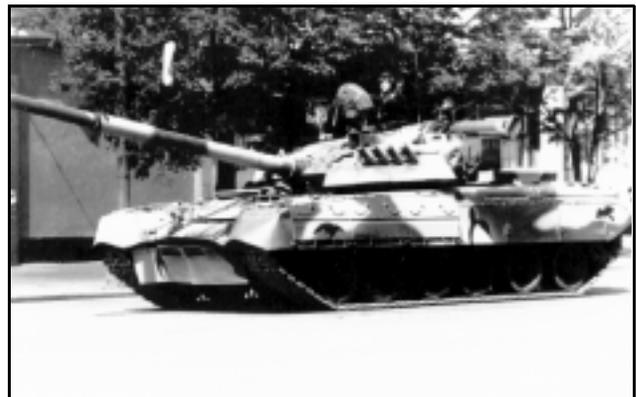
T-80U in first public appearance on parade in Red Square.

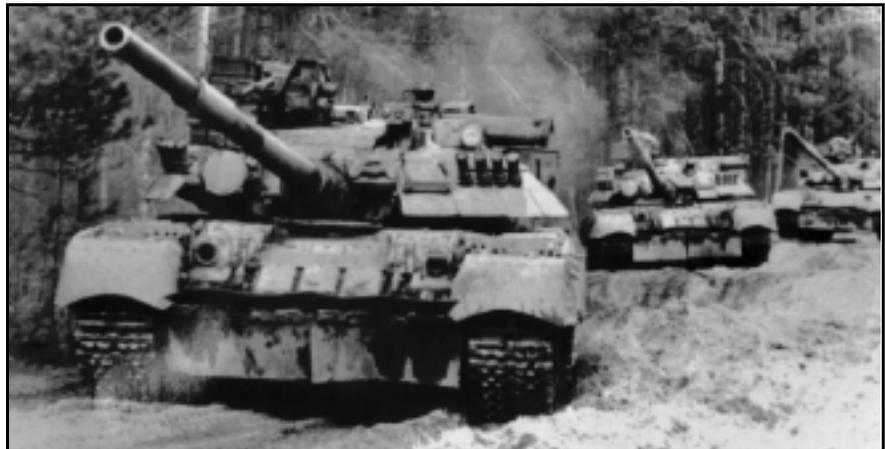
One of the first declassified pictures of the T-80U, seen on maneuvers in 1989.
